## PROPERTY CONDITION ASSESSMENT

1234 Sample Street, Bradenton, FL 34203

Sample Client  
5/15/2026 9:00AM

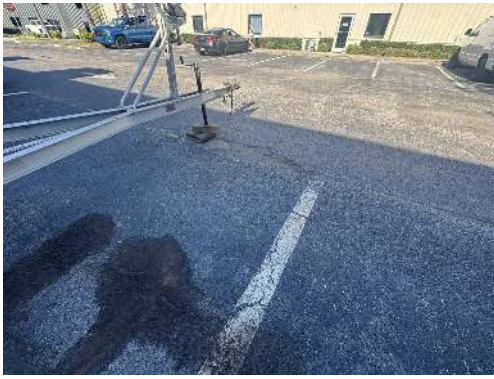
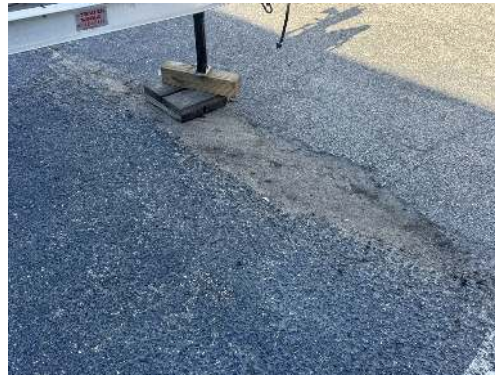
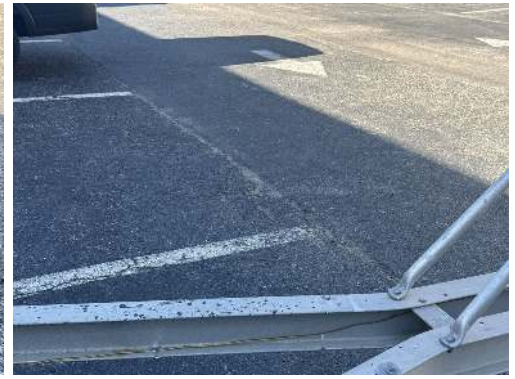
Localized settlement and depressed areas were observed in portions of the asphalt parking lot. Settlement of paved areas may indicate compaction or saturation of the underlying subgrade, failure of the base course, or compromised subsurface drainage. Left uncorrected, depressed areas tend to collect standing water, accelerate pavement deterioration, and may develop into potholes or alligator cracking. Recommend evaluation and repair by a qualified paving contractor. Repairs typically include saw-cut removal of the affected areas, base course correction, and asphalt patching with subsequent sealcoating to restore a uniform surface.

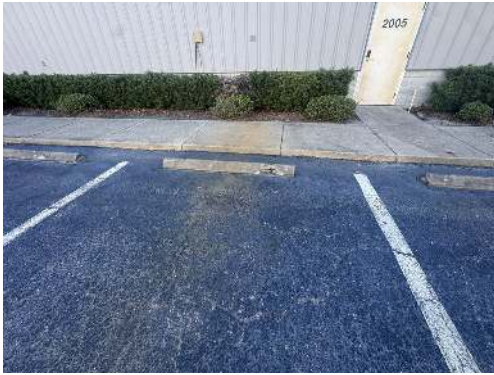
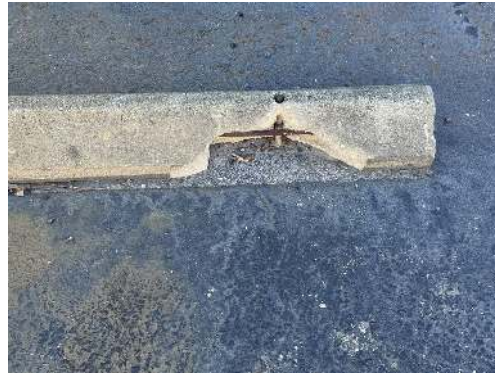
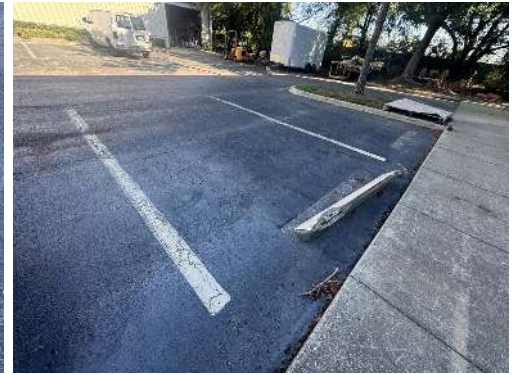
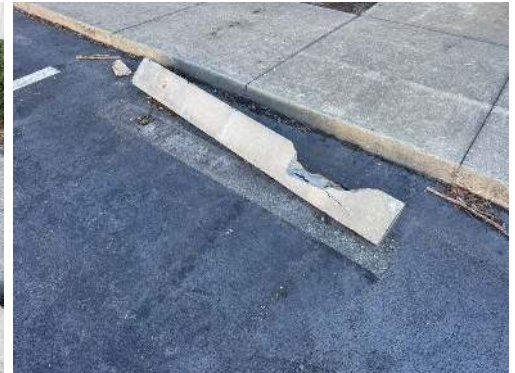
### 6.1.2 Damaged Parking Blocks

**Damaged parking blocks** were observed at the site. Deteriorated, broken, or displaced parking blocks can create a trip hazard and may not properly protect vehicles, sidewalks, or adjacent structures from impact. This condition can also worsen over time with continued vehicle contact and weather exposure. *Repair or replacement by a qualified contractor is recommended to improve safety and maintain proper function.*

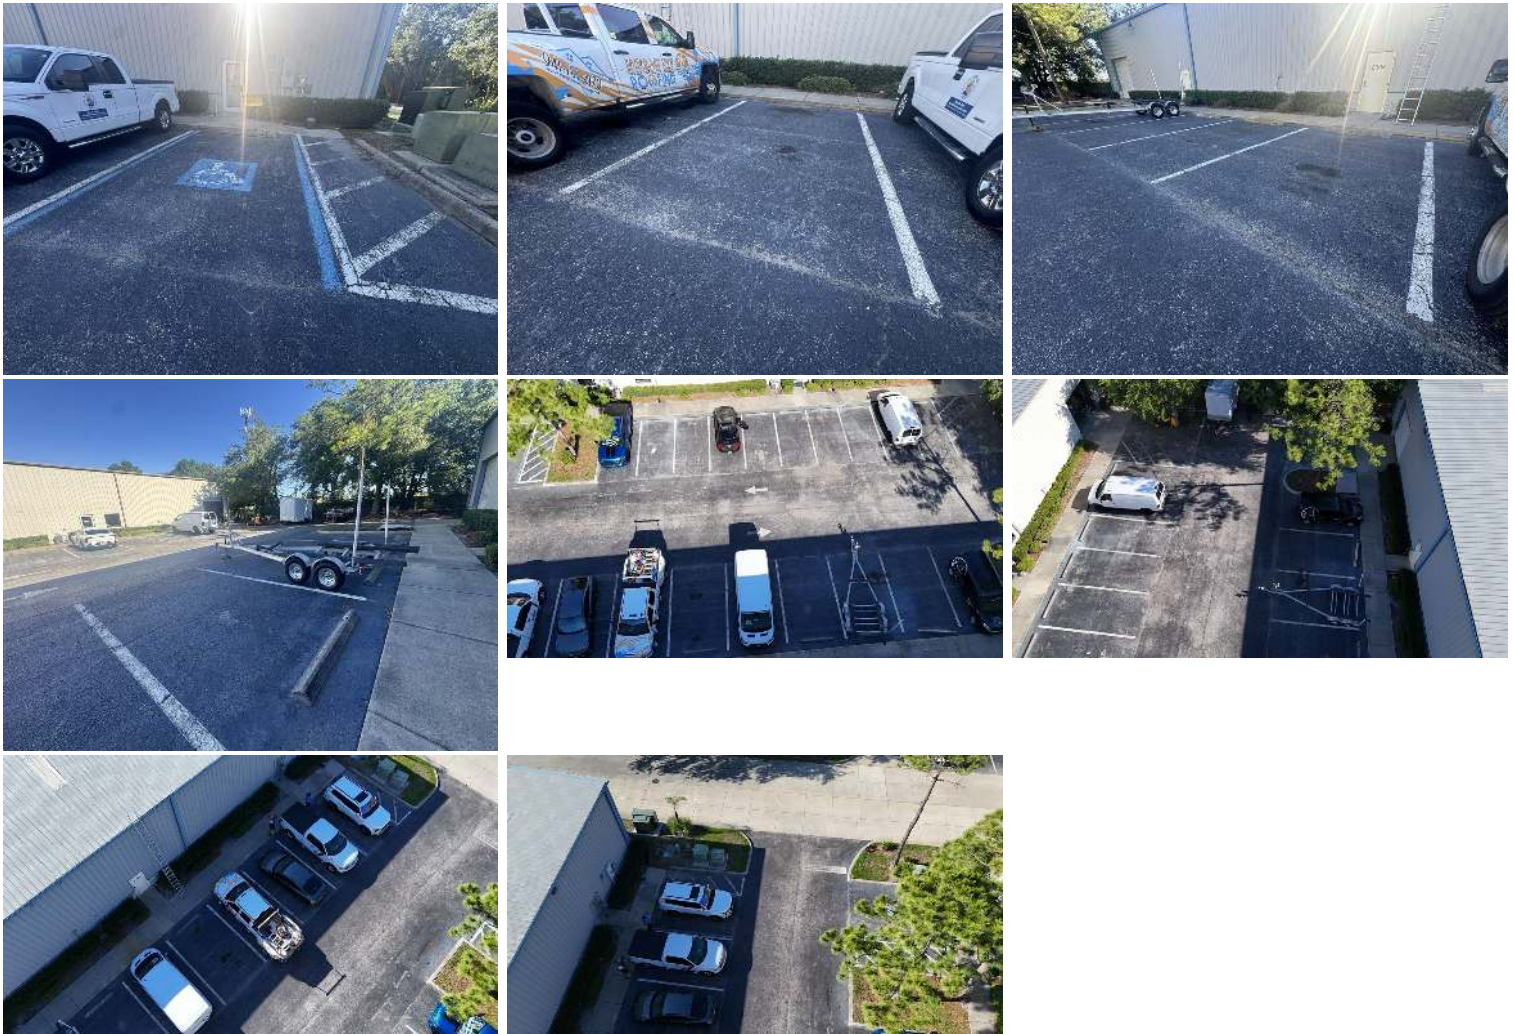
### 6.1.3 Saelcoat is Aging

The sealcoat was observed to be aging. As sealcoat deteriorates, the pavement surface becomes more vulnerable to moisture intrusion, UV damage, and accelerated wear. This condition can shorten the service life of the paved surface if not addressed. I recommend maintenance or resealing by a qualified paving contractor as needed to help protect the pavement and extend its lifespan.

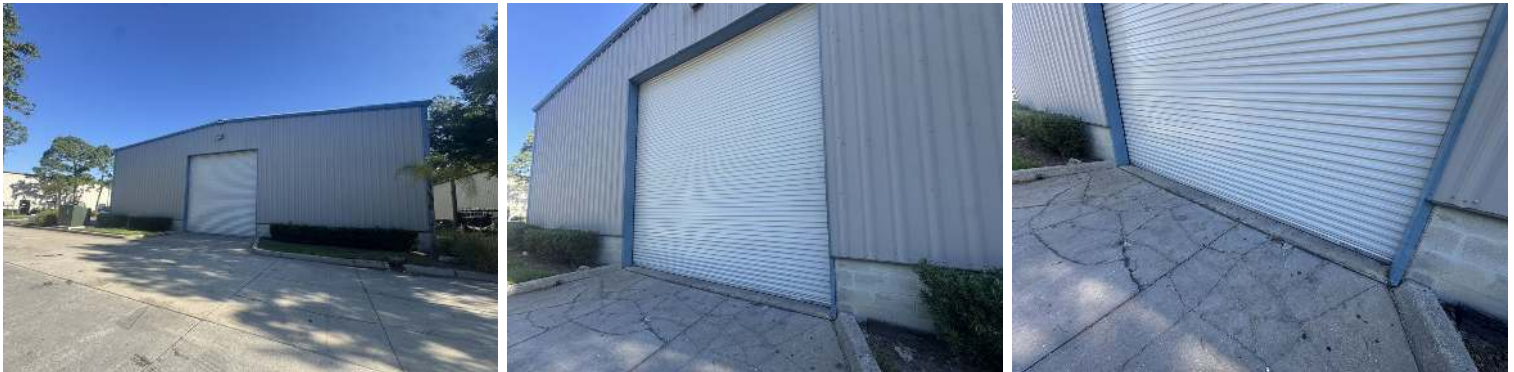
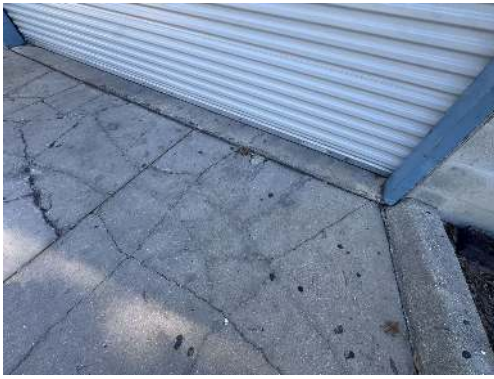
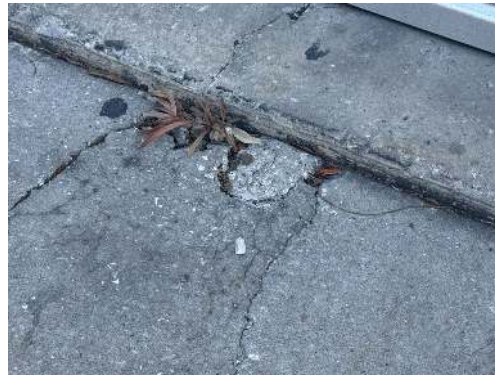
#### 6.1.4 Slab Settlement Cracks

Cracking was observed in exterior concrete flatwork adjacent to the building, including areas at the overhead door apron. Cracks of this nature are commonly associated with minor settlement, thermal movement, or shrinkage, and are typical for slabs of this age in the region. While the observed cracking did not appear to indicate active or significant differential movement at the time of inspection, open cracks can allow moisture and debris intrusion and may worsen over time. Recommend evaluation and repair by a qualified concrete contractor. Repairs may include crack routing, sealant application, or partial slab replacement depending on extent. Continued periodic monitoring is recommended.

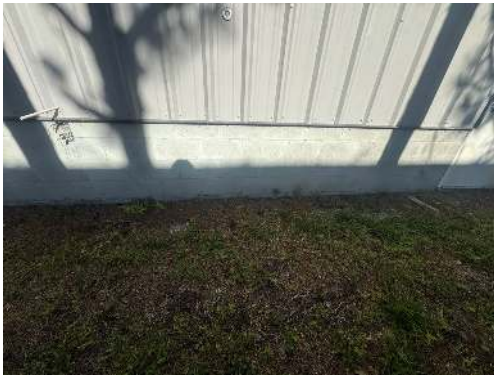
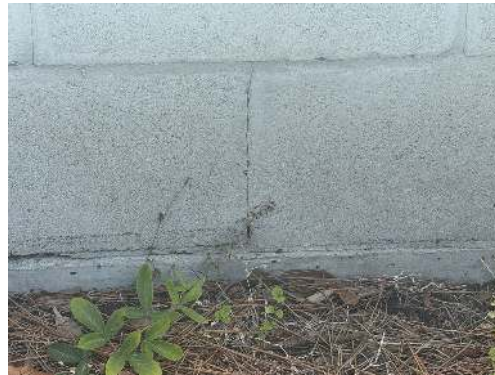
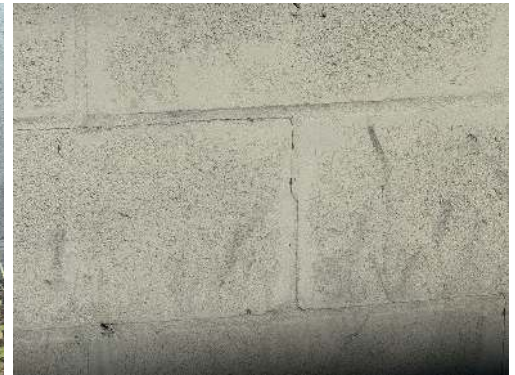
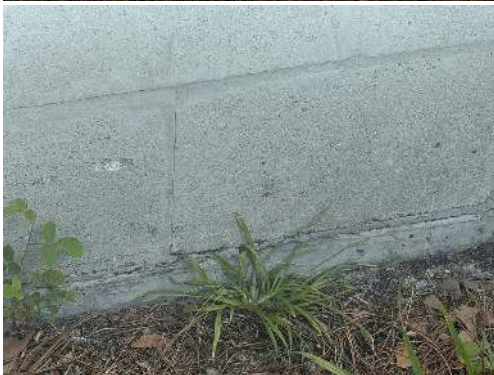
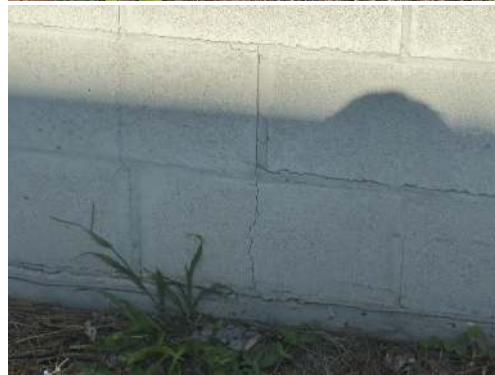
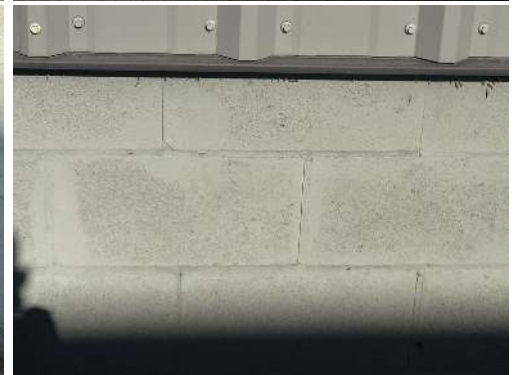
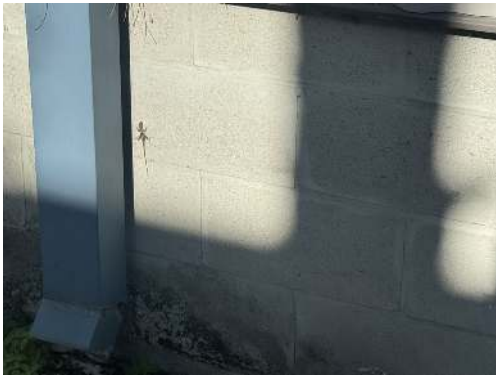
Cracking was observed in portions of the exterior CMU (concrete masonry unit) knee walls. Cracks in masonry walls may result from minor settlement, thermal expansion and contraction, or the natural curing of the masonry. While the observed cracks did not appear to be structurally significant at the time of inspection, open cracks in unsealed masonry can allow moisture intrusion, which in Florida's climate can accelerate deterioration of the masonry, embedded reinforcement, and adjacent metal panel framing. Recommend evaluation and repair by a qualified masonry or waterproofing contractor. Typical correction includes tuckpointing or routing and sealing of the affected joints, followed by a protective coating where appropriate.

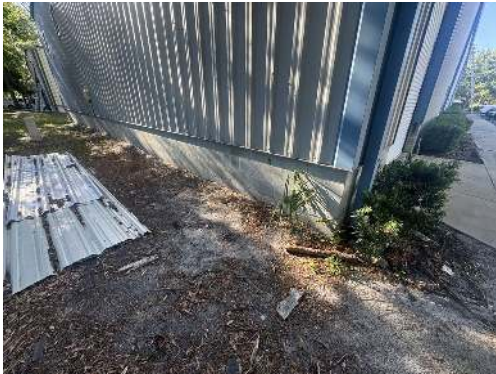
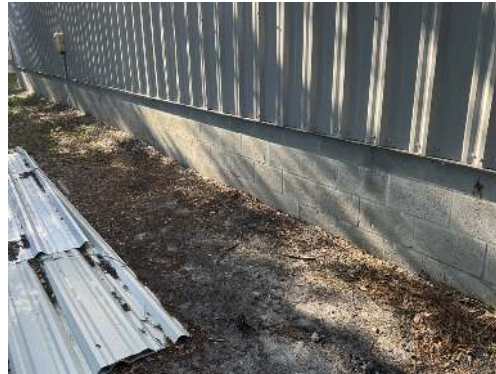
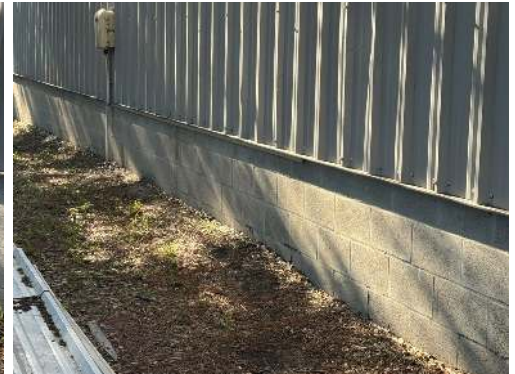
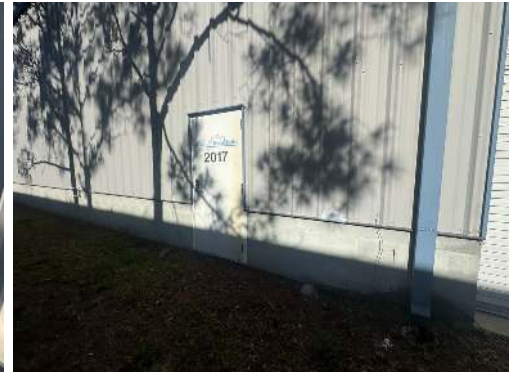
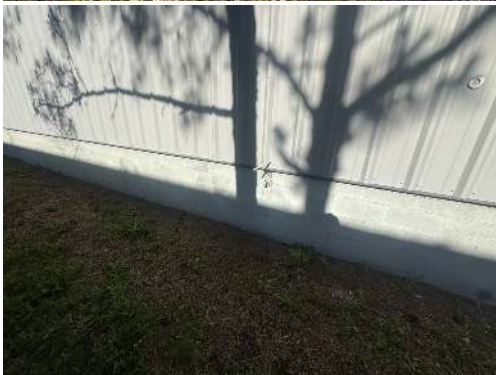
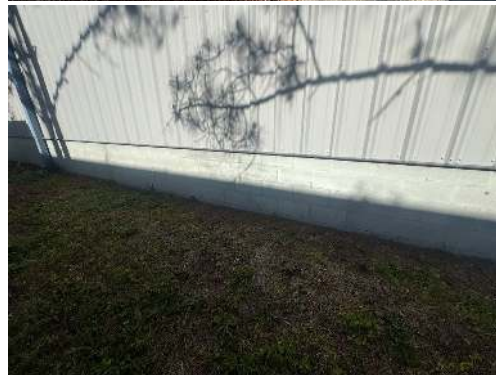
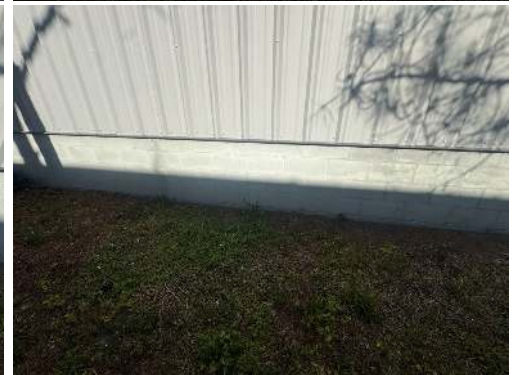
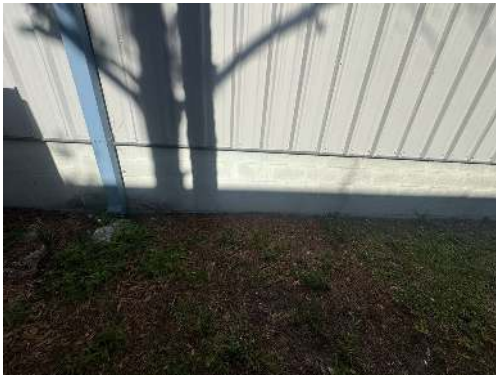
### 6.2.2 Masonry Not Sealed

The exterior CMU knee walls appeared to be unsealed and unpainted in multiple locations. Unsealed concrete masonry is porous and absorbs moisture readily, particularly in Florida's high-humidity environment. Over time, this can lead to spalling, efflorescence, accelerated deterioration of the wall, and water migration into the interior. Recommend application of a breathable masonry sealer or elastomeric coating by a qualified contractor to protect the masonry, improve weather resistance, and extend the service life of the wall assembly.

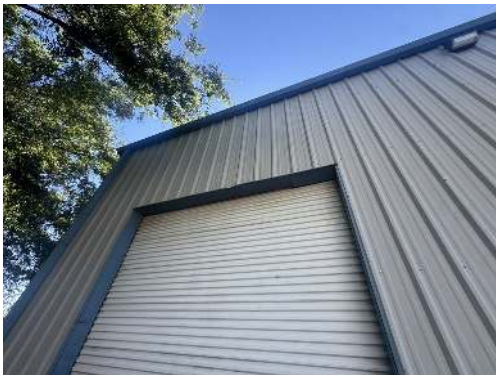
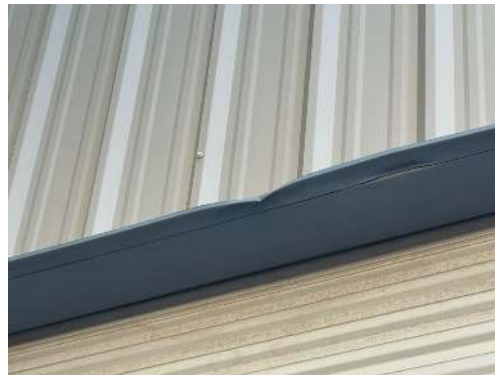
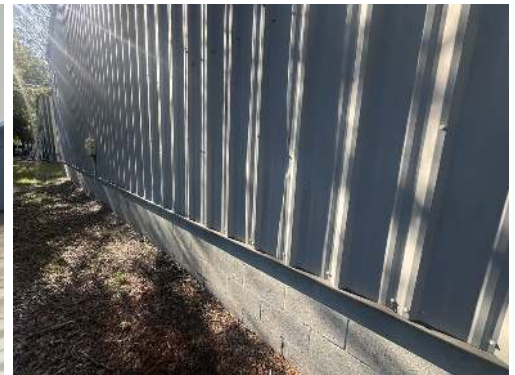
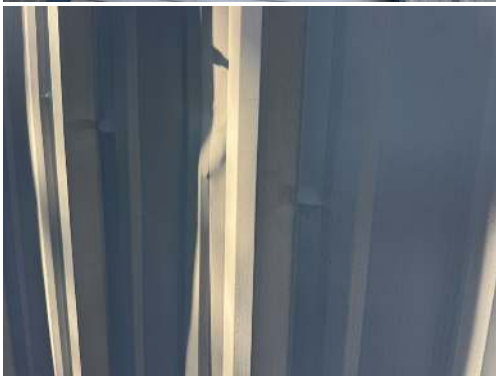
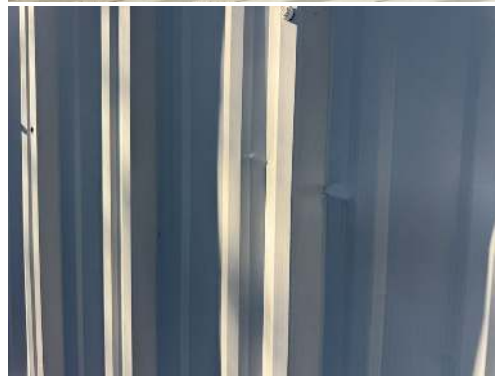
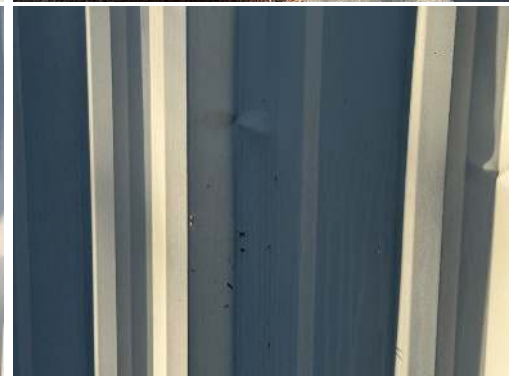
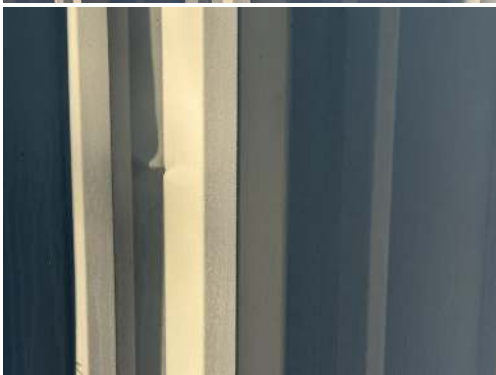
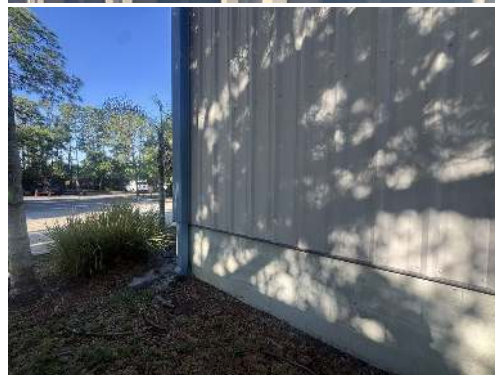
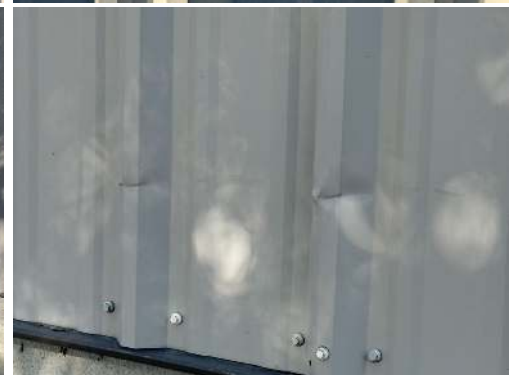
### 6.2.3 Metal Siding Is Dented

Metal siding was observed to be dented in one or more areas. The damaged sections should be repaired or replaced as needed to restore the siding surface. Recommend repair by a qualified contractor. Further evaluation is recommended if additional concealed damage is suspected.

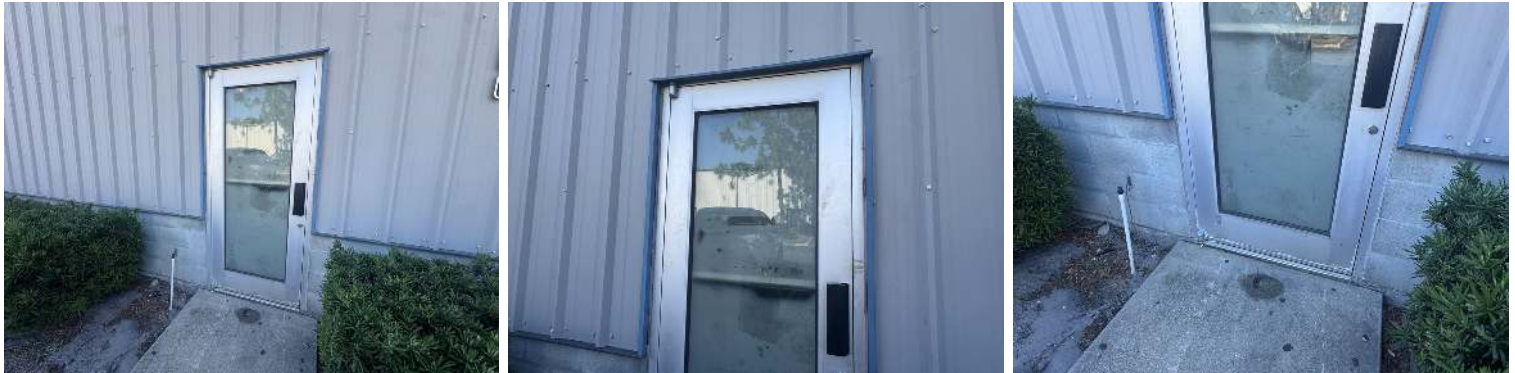
Fogging and condensation between the panes of insulated glazing was observed at one or more exterior personnel door glass lites. Fogging of this nature indicates failure of the perimeter seal of the insulated glass unit (IGU), which compromises the unit's thermal performance and is generally not repairable. Recommend replacement of the affected glazing units by a qualified glazing contractor. Replacement should be made with units that meet current Florida Building Code wind-borne debris and impact requirements applicable to the property's wind zone.

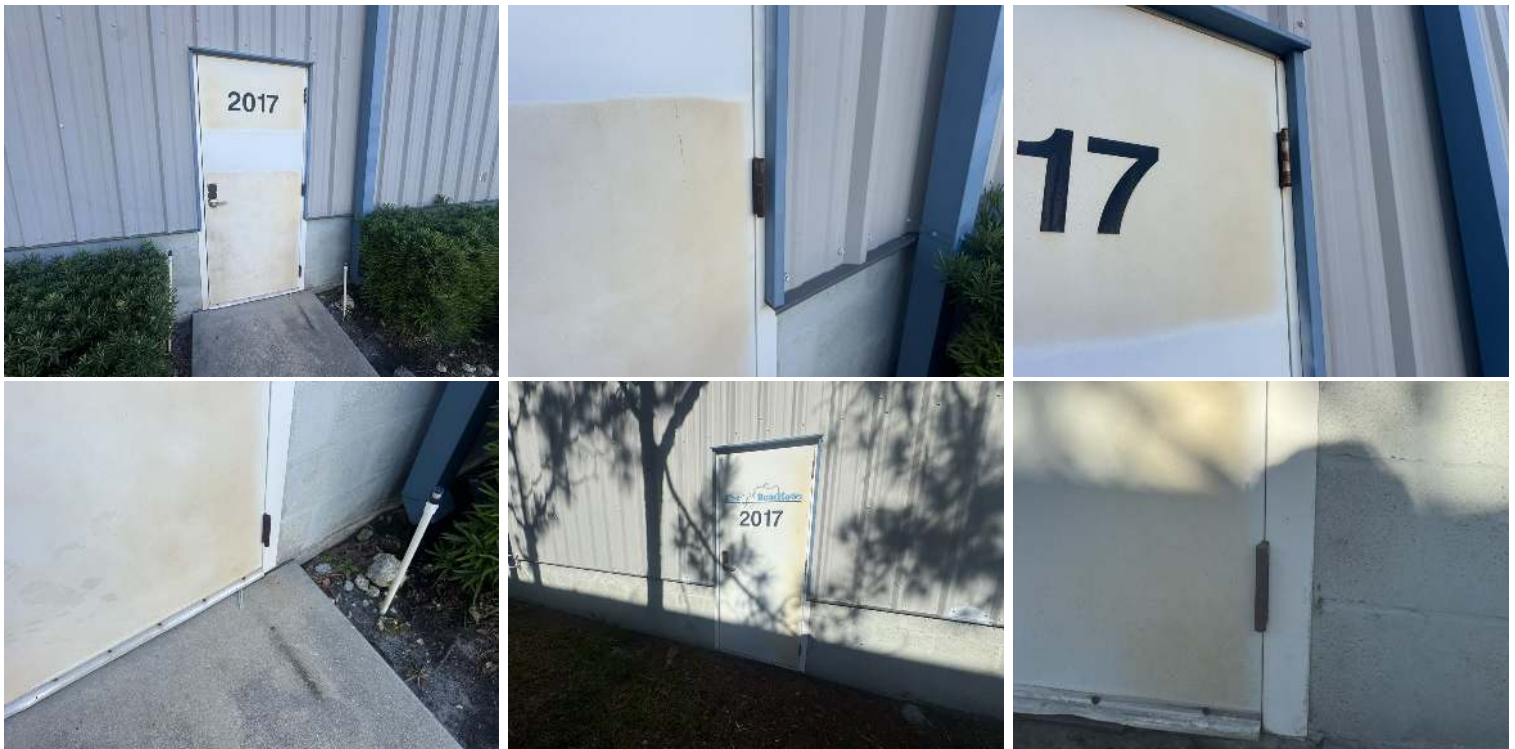
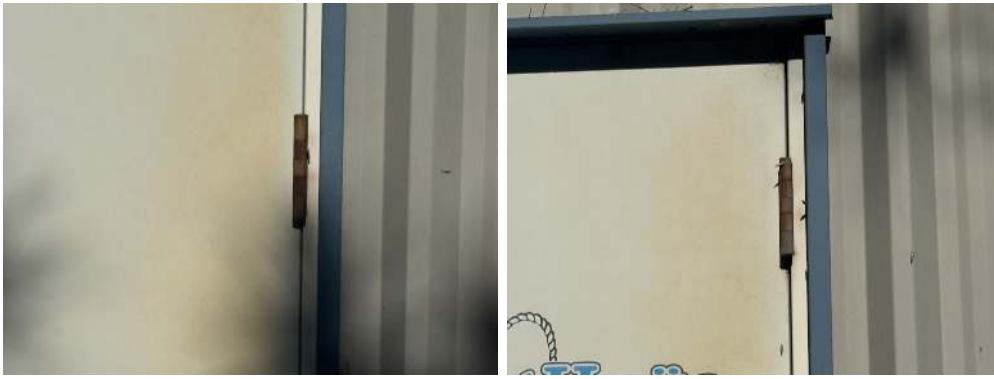
### 6.3.2 Rusted Hinges

Corrosion was observed on exterior door hinges and adjacent hardware. Corrosion of exterior hardware is common in coastal and subtropical environments due to elevated humidity and salt-air exposure. Continued deterioration may compromise door operation, security, and weather resistance over time. Recommend cleaning, treatment, and replacement of affected hinges and hardware by a qualified contractor, with substitution of corrosion-resistant (stainless steel or coated) hardware where practical.

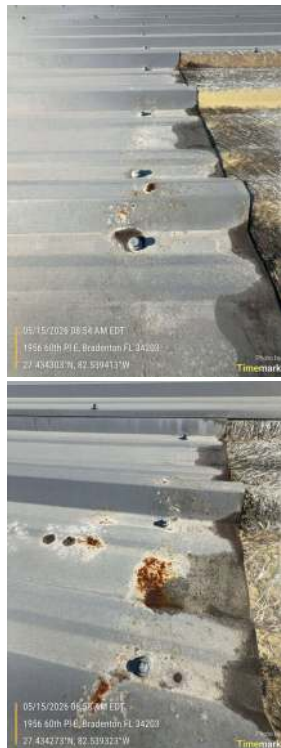
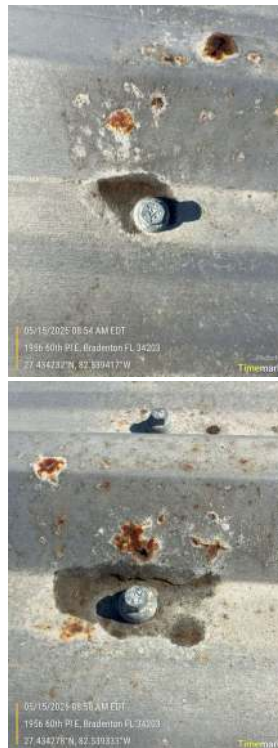
The metal roof covering exhibited surface oxidation, finish wear, and minor surface deterioration consistent with the age and exposure of the roofing system. Cumulative effects of UV exposure, thermal cycling, and weathering — particularly pronounced in Florida — gradually reduce the protective coating and increase susceptibility to corrosion. Although the roof appeared generally serviceable at the time of inspection, periodic maintenance and an eventual recoating or replacement should be anticipated. Recommend ongoing monitoring and evaluation by a qualified roofing contractor to establish a maintenance program, including consideration of an elastomeric roof coating system to extend remaining useful life.

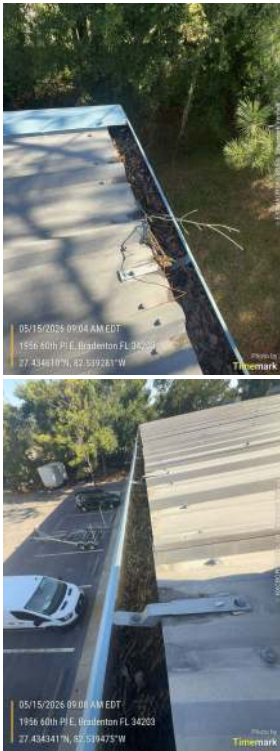
#### 6.4.2 Improper Drainage

Improper drainage was observed at the property. Water was not being directed to drain properly from the affected area. Recommend evaluation and correction by a qualified contractor. Repair is recommended to improve drainage performance.

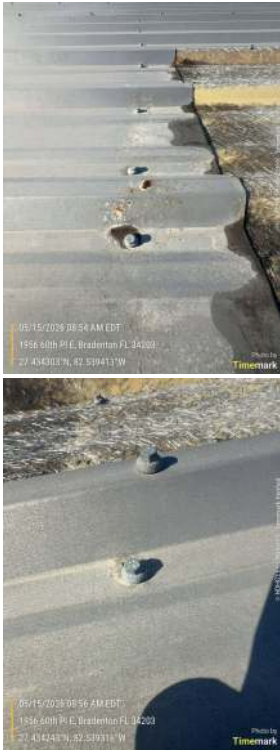
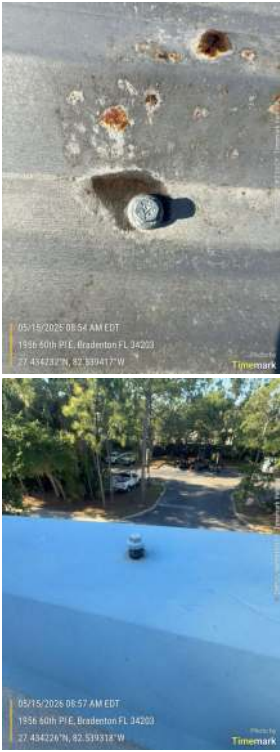
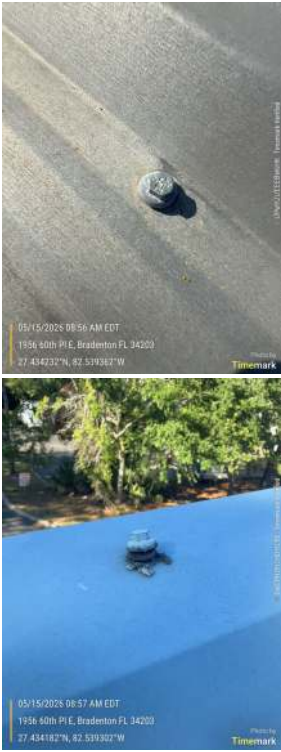
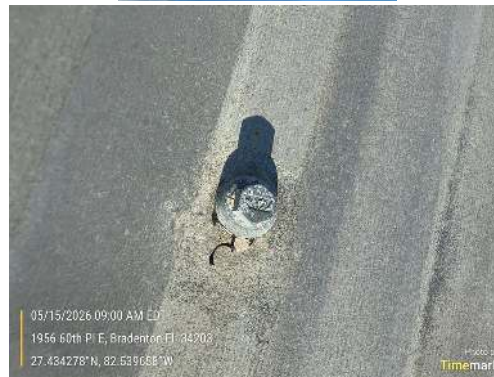
6.4.3 Roof Fasteners Are Loose and Corroded

Multiple roof panel fasteners were observed to be backed out, loose, or showing significant corrosion at the gasket and washer assembly, with rust streaking extending across the metal roof surface. A roof-mounted vent assembly was also observed to be damaged at the time of inspection. These conditions present an active water intrusion risk and should be addressed promptly by a qualified commercial roofing contractor, including fastener and gasket replacement, vent repair or replacement, and evaluation of adjacent panels and flashings.

Loose and corroded fasteners were observed at the roofing system. Repair is recommended to secure or replace the affected fasteners as needed. Recommend evaluation and repair by a qualified roofing contractor. Further review of surrounding roof components is also recommended during repairs.

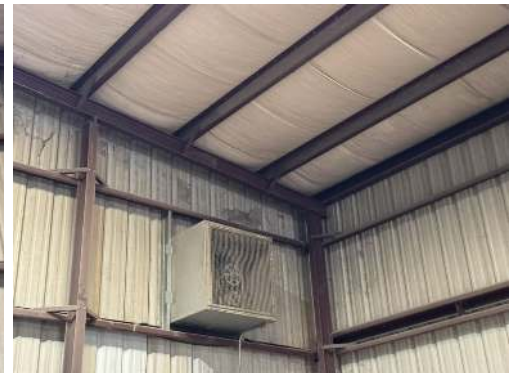
Two wall-mounted exhaust/ventilation fans serve the warehouse area. At the time of the inspection, no electrical power was available to the units and they could not be operated or evaluated for functional condition. The interior of the building did not appear to contain conditioned (heated and cooled) air handling equipment. Recommend re-evaluation of the ventilation equipment once power is restored, and that the operational condition, age, capacity, and remaining useful life of all mechanical equipment be confirmed by a qualified HVAC contractor prior to closing or occupancy.

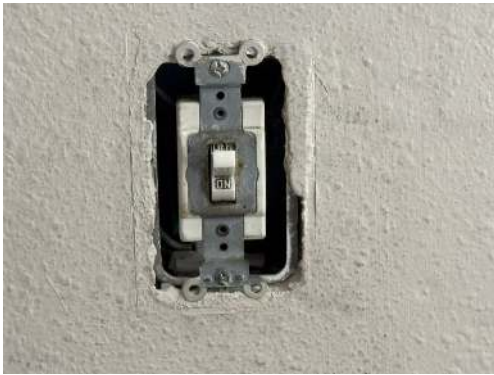
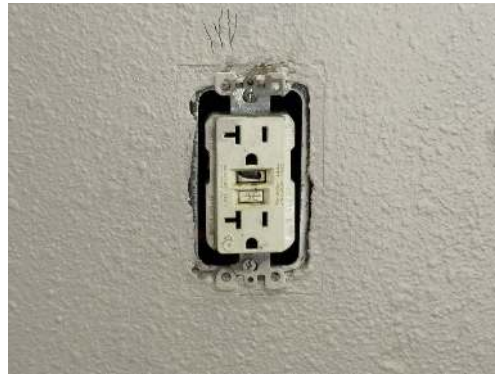
Cover plate(s) absent; install to reduce shock hazard.

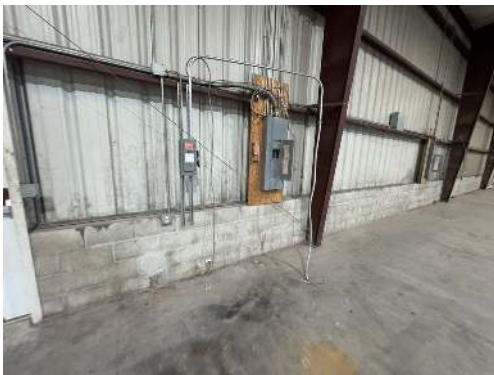
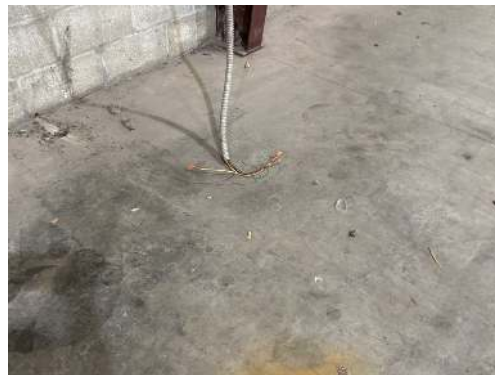
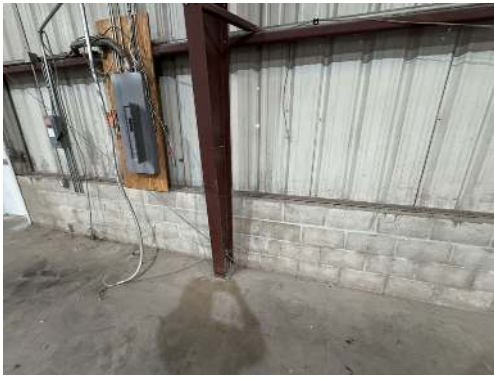
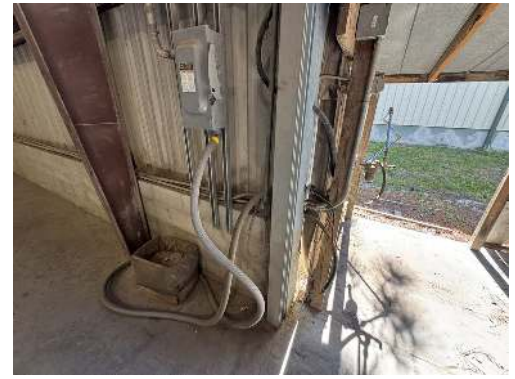
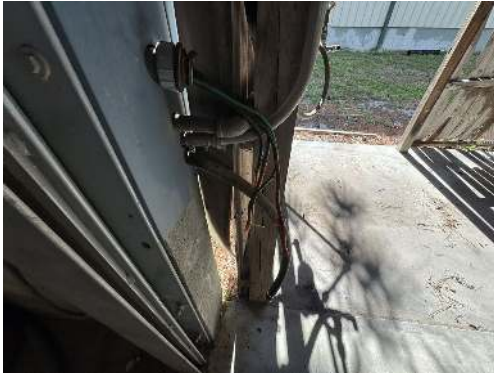
#### 6.6.10 **Exposed Wiring**

Wiring exposed without conduit or protection; repair recommended.

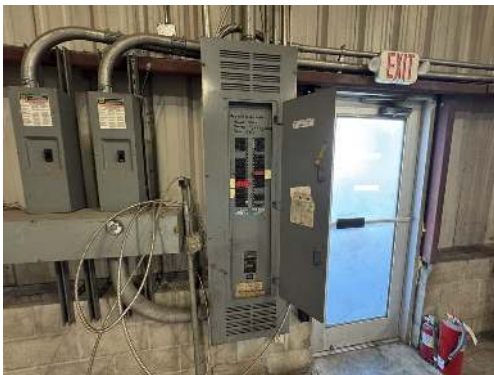
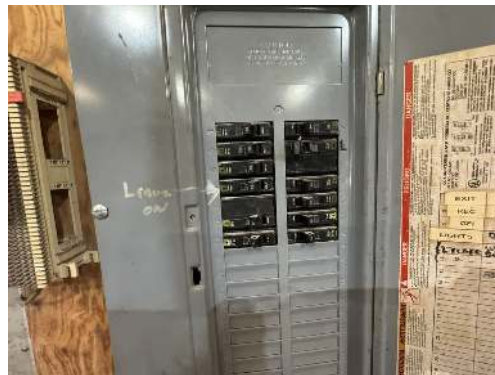
### 6.6.11 Multiple Breakers Turned Off

Multiple breakers were observed in the off position at the time of inspection. The affected circuits were not evaluated further during the inspection. Recommend determining why these breakers are turned off and having any needed corrections made by a qualified electrician.

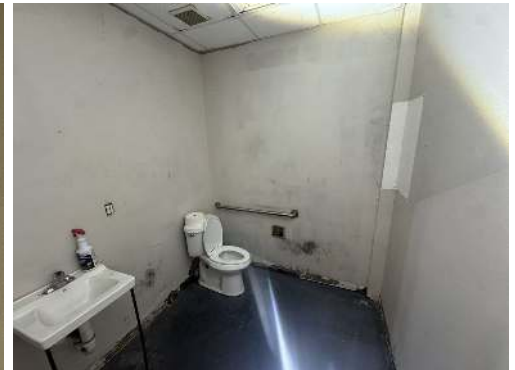
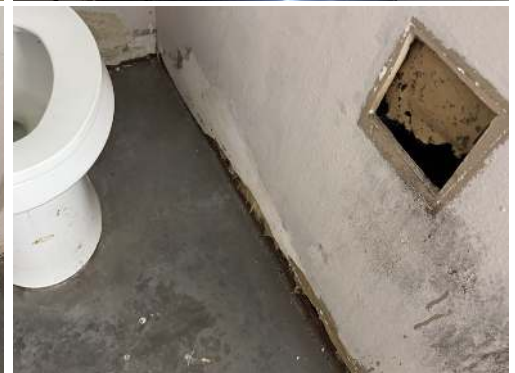
The overall bathroom condition showed items that need attention at the time of inspection. Visible deficiencies were noted in this area, and repair or correction is recommended as needed. Recommend further evaluation and repair by a qualified contractor. Repairs should be completed to address the observed bathroom condition.

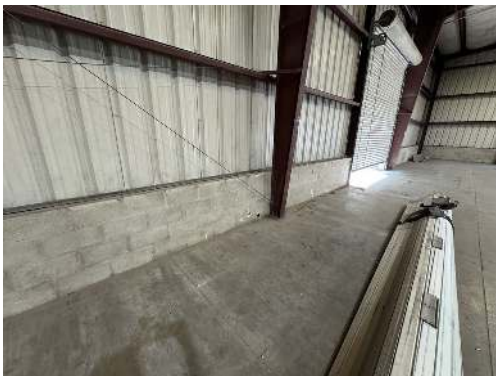
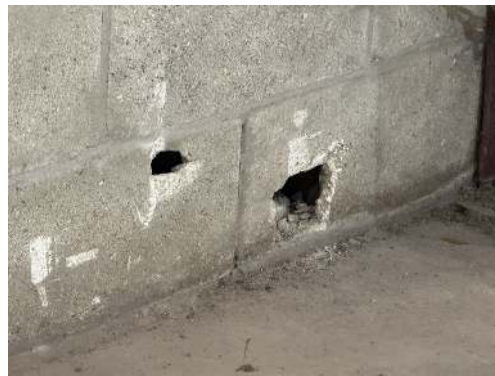
Damage was observed in the masonry. Repair is recommended by a qualified masonry contractor. Recommend evaluation and repair of the affected areas as needed. Further review should be completed to determine the full extent of repairs.

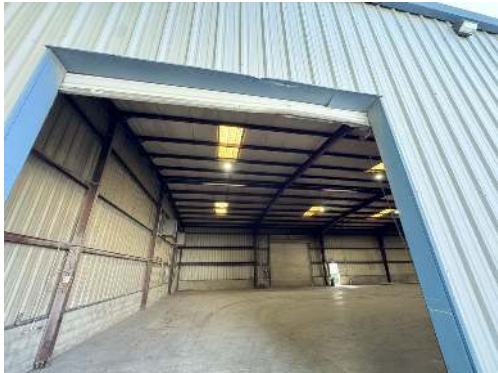
Damage was observed at the garage door. Recommend repair or replacement by a qualified garage door contractor. Further evaluation of the door and related hardware is recommended to determine the full extent of needed repairs. Repair is recommended.

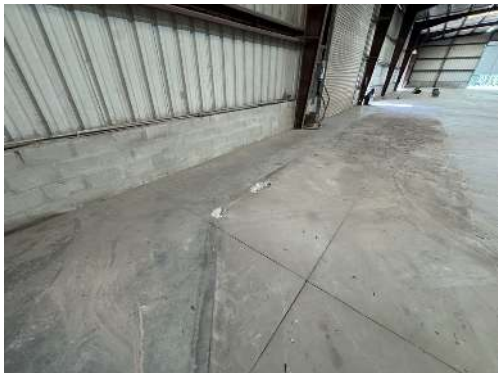
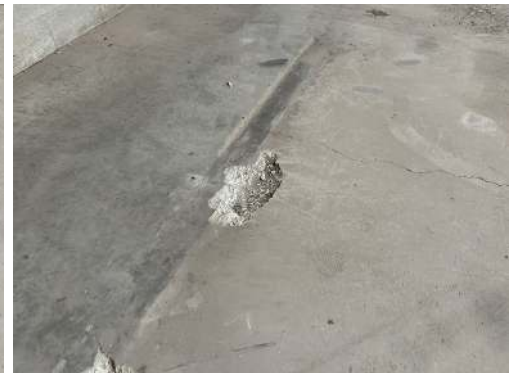
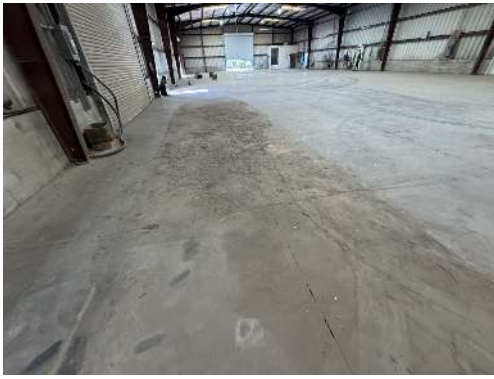
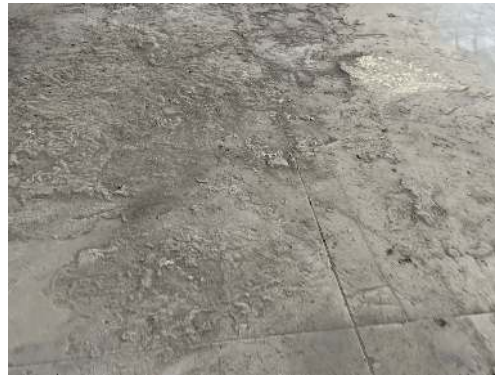
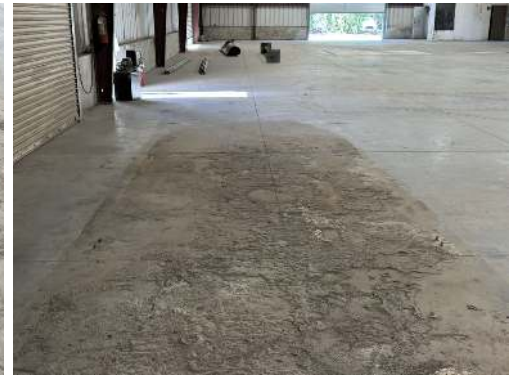
#### 6.8.6 Slab Damaged

Damage was observed at the slab. Repair is recommended.

Recommend evaluation and repair by a qualified contractor as needed. Further monitoring may be needed after corrections are made.

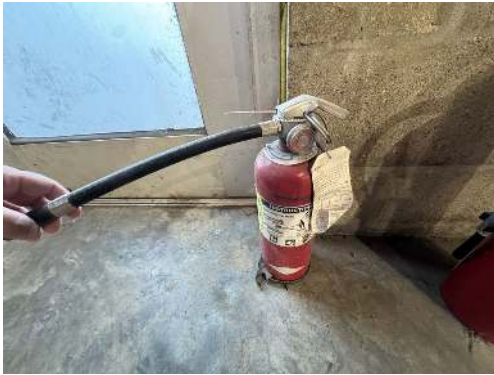
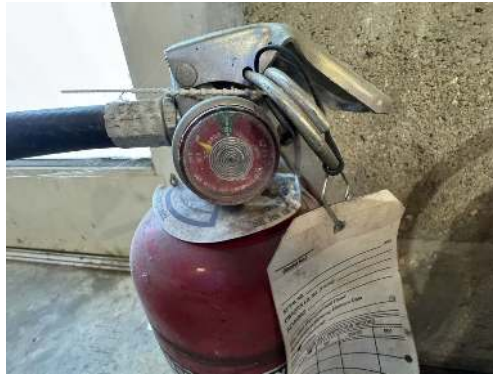
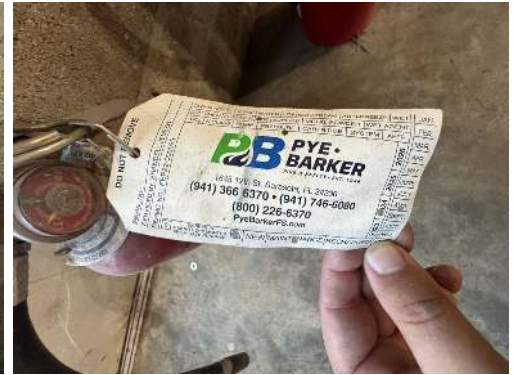
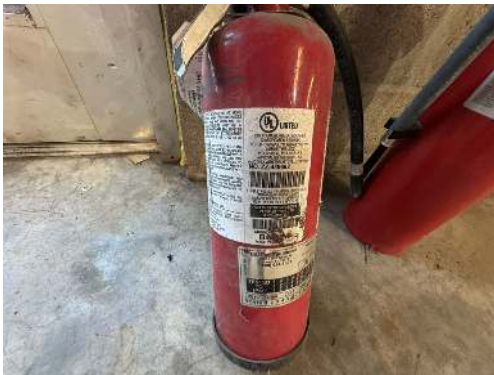
The fire extinguisher inspection was past due at the time of the inspection. The unit should be inspected and serviced in accordance with the manufacturer's guidelines. Recommend evaluation and servicing by a qualified fire safety company. Replace the extinguisher if it cannot be properly serviced or is no longer considered reliable.
