## PROPERTY CONDITION ASSESSMENT

1234 Sample Street, Bradenton, FL 34203

Sample Client  
5/15/2026 9:00AM

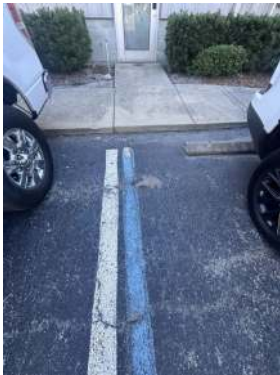
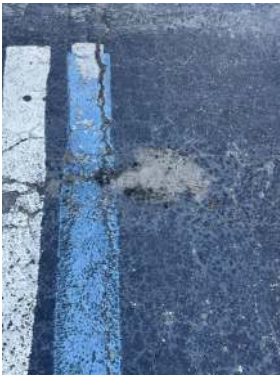
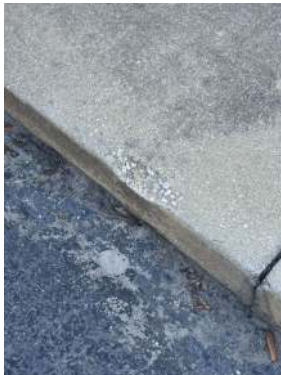
Localized settlement and depressed areas were observed in portions of the asphalt parking lot. Settlement of paved areas may indicate compaction or saturation of the underlying subgrade, failure of the base course, or compromised subsurface drainage. Left uncorrected, depressed areas tend to collect standing water, accelerate pavement deterioration, and may develop into potholes or alligator cracking. Recommend evaluation and repair by a qualified paving contractor. Repairs typically include saw-cut removal of the affected areas, base course correction, and asphalt patching with subsequent sealcoating to restore a uniform surface.

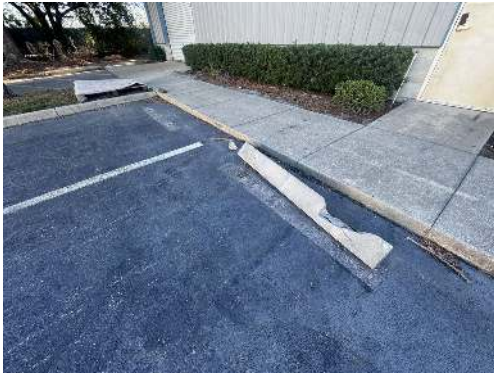
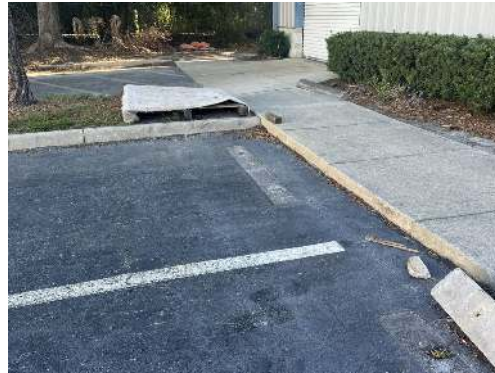
### 6.1.2 Damaged Parking Blocks

**Damaged parking blocks** were observed at the site. Deteriorated, broken, or displaced parking blocks can create a trip hazard and may not properly protect vehicles, sidewalks, or adjacent structures from impact. This condition can also worsen over time with continued vehicle contact and weather exposure. *Repair or replacement by a qualified contractor is recommended to improve safety and maintain proper function.*

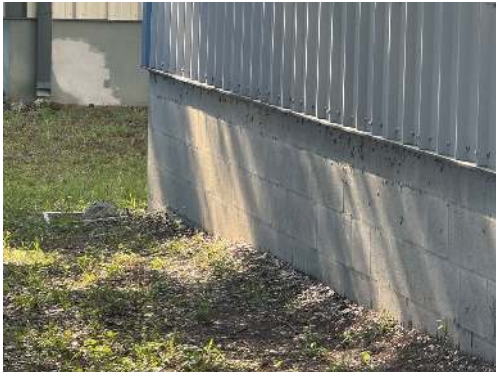
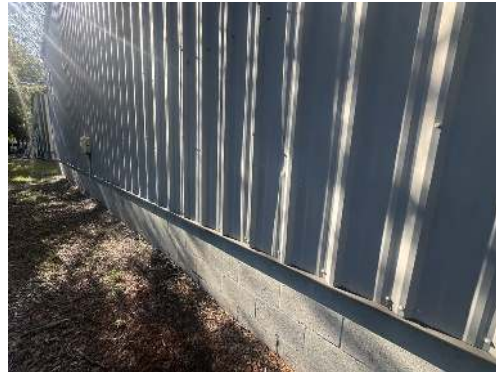
The exterior CMU knee walls exhibit cracking at multiple locations and appear to be largely unsealed and unpainted. Unsealed CMU is porous and absorbs moisture readily, particularly in Florida's high-humidity environment, accelerating deterioration of the masonry, embedded reinforcement, and adjacent metal panel framing. Comprehensive envelope protection including crack repair, joint sealant replacement, and application of a breathable masonry sealer or elastomeric coating by a qualified contractor is recommended.

The exterior CMU knee walls appeared to be unsealed and unpainted in multiple locations. Unsealed concrete masonry is porous and absorbs moisture readily, particularly in Florida's high-humidity environment. Over time, this can lead to spalling, efflorescence, accelerated deterioration of the wall, and water migration into the interior. Recommend application of a breathable masonry sealer or elastomeric coating by a qualified contractor to protect the masonry, improve weather resistance, and extend the service life of the wall assembly.

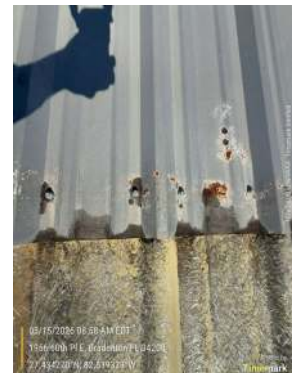
The metal roof covering exhibited surface oxidation, finish wear, and minor surface deterioration consistent with the age and exposure of the roofing system. Cumulative effects of UV exposure, thermal cycling, and weathering — particularly pronounced in Florida — gradually reduce the protective coating and increase susceptibility to corrosion. Although the roof appeared generally serviceable at the time of inspection, periodic maintenance and an eventual recoating or replacement should be anticipated. Recommend ongoing monitoring and evaluation by a qualified roofing contractor to establish a maintenance program, including consideration of an elastomeric roof coating system to extend remaining useful life.

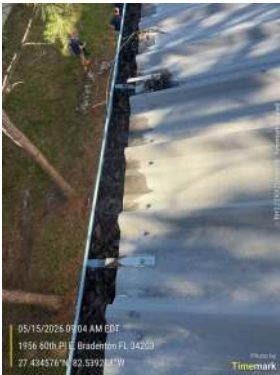
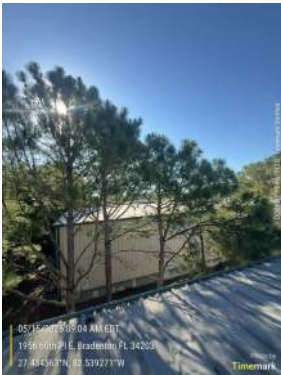
#### 6.4.2 Improper Drainage

Improper drainage was observed at the property. Water was not being directed to drain properly from the affected area. Recommend evaluation and correction by a qualified contractor. Repair is recommended to improve drainage performance.

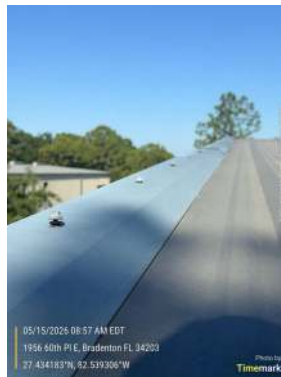
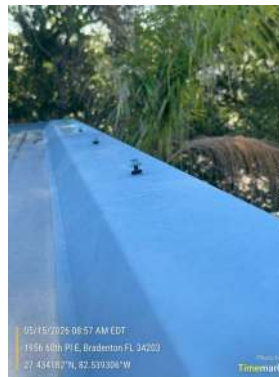
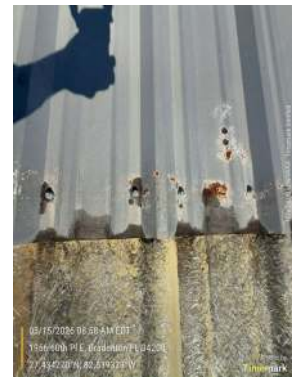
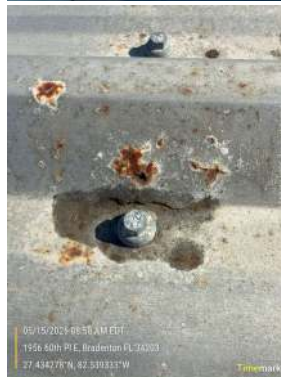
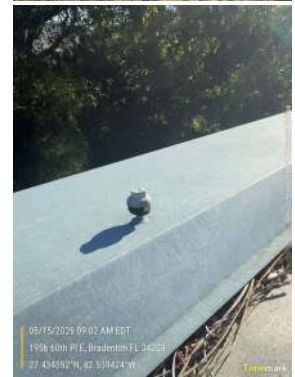
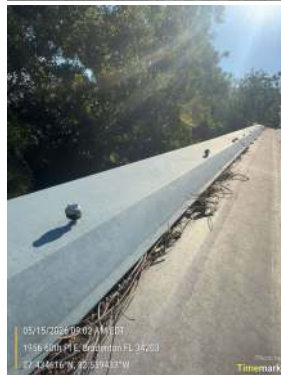
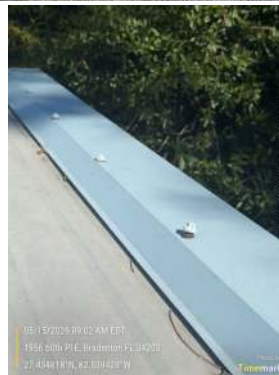
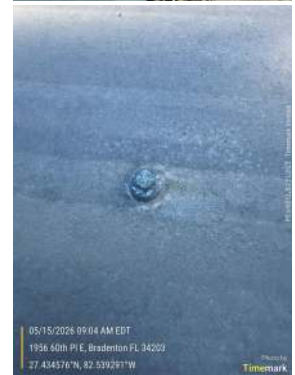
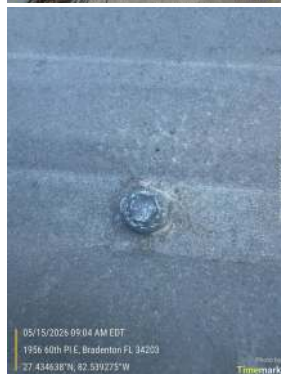
6.4.3 Roof Fasteners Are Loose and Corroded

The low-slope metal roof system exhibits backed-out and corroded fasteners with degraded gaskets at multiple locations, evident rust streaking across the panel surface, improper drainage along portions of the perimeter, and a damaged roof vent assembly with apparent gaps in its closure. These conditions present an active water intrusion pathway and reduced wind-uplift resistance during severe weather events typical of the Bradenton, Florida market. Evaluation and repair by a qualified commercial roofing contractor is recommended, including fastener and gasket replacement, drainage correction, and vent repair or replacement.

Loose and corroded fasteners were observed at the roofing system. Repair is recommended to secure or replace the affected fasteners as needed. Recommend evaluation and repair by a qualified roofing contractor. Further review of surrounding roof components is also recommended during repairs.

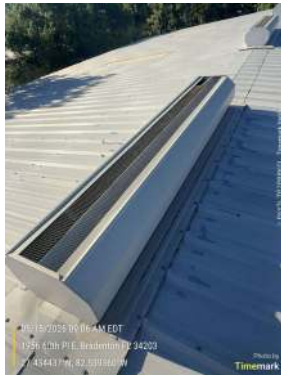
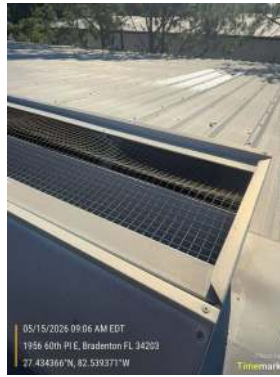
#### 6.4.4 Roof Vent Damaged

A roof vent was observed to be damaged at the time of inspection. Repair is recommended by a qualified roofing contractor. Recommend evaluation of the vent and any related roof covering around the damaged area. Further repair or replacement may be needed as determined by the contractor.

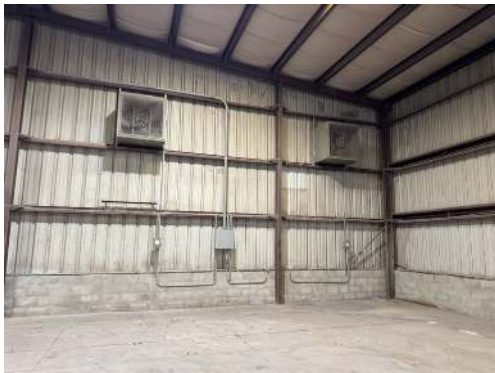
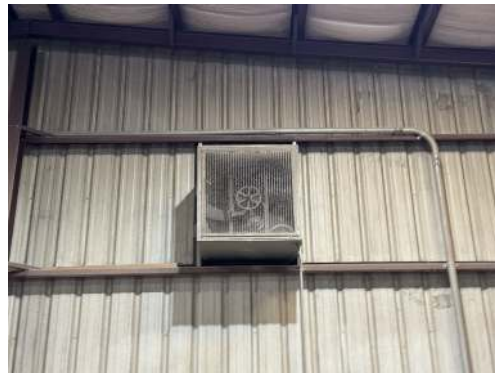
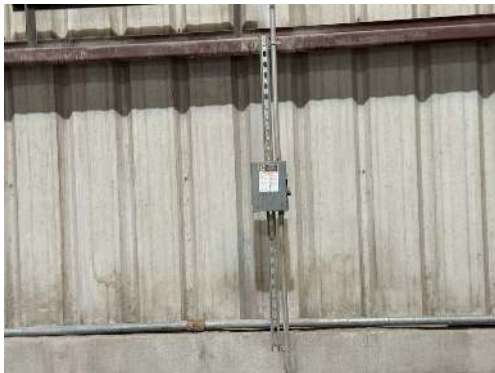
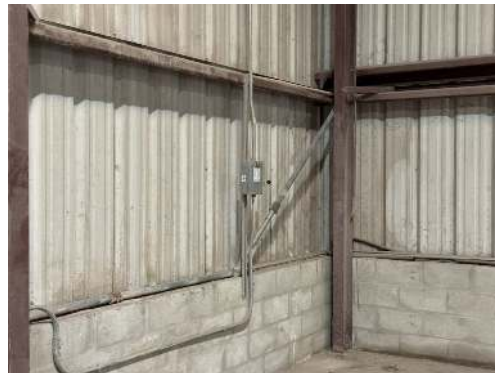
Two wall-mounted exhaust/ventilation fans serve the warehouse area. At the time of the inspection, no electrical power was available to the units and they could not be operated or evaluated for functional condition. The interior of the building did not appear to contain conditioned (heated and cooled) air handling equipment. Recommend re-evaluation of the ventilation equipment once power is restored, and that the operational condition, age, capacity, and remaining useful life of all mechanical equipment be confirmed by a qualified HVAC contractor prior to closing or occupancy.

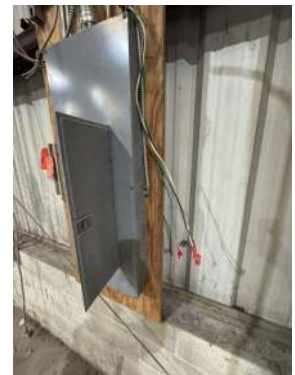
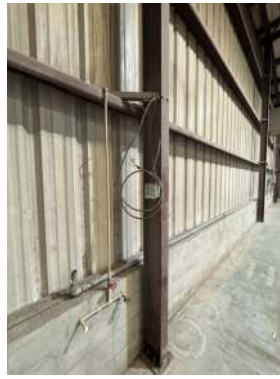
Sections of branch wiring were observed routed without conduit or other approved protection, one or more switches and receptacles were observed without cover plates installed, and multiple circuit breakers were observed in the OFF position with the affected loads not available for evaluation. These conditions present shock, arc-fault, and fire hazards and prevent complete evaluation of the electrical system. Correction by a Florida-licensed electrical contractor is recommended.

Wiring exposed without conduit or protection; repair recommended.

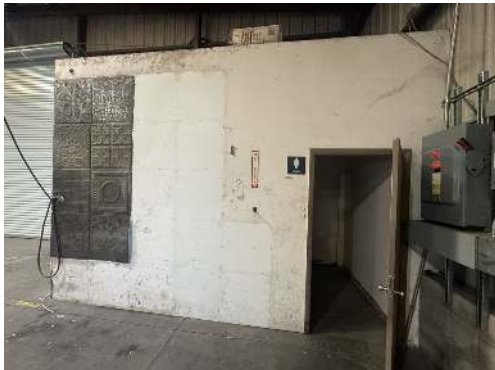
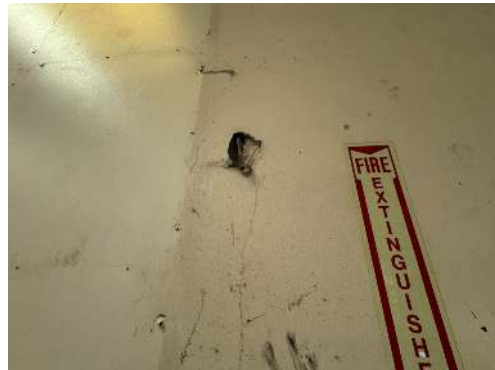
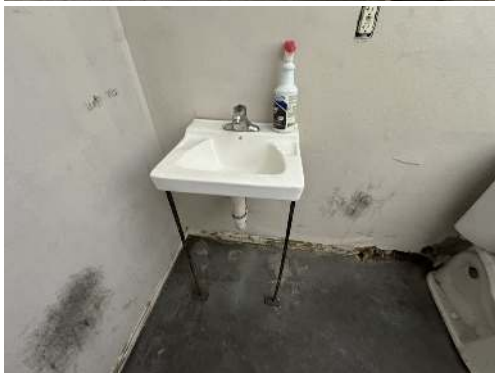
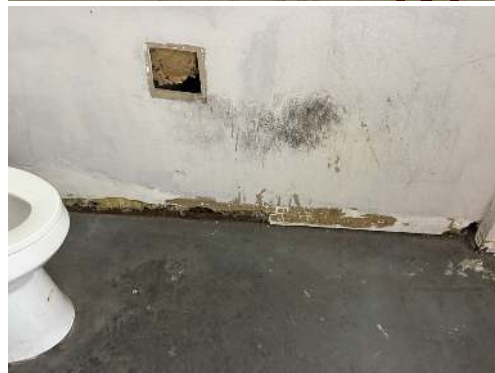
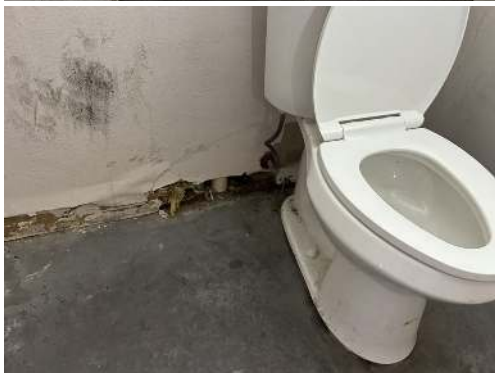
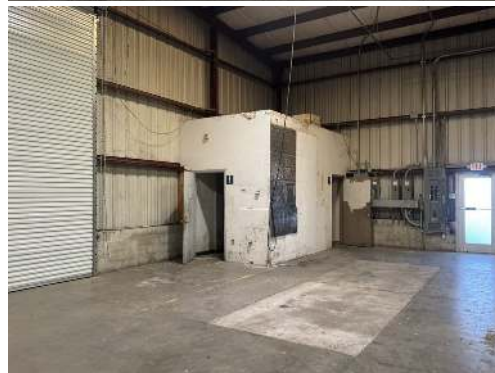
The interior restroom area exhibits extensive dark staining along the lower walls and floor-wall interface, apparent surface deterioration of wall finishes, and visible openings in the wall assembly. The conditions are visually consistent with prolonged moisture exposure and possible microbial (mold) growth, which may present indoor air quality concerns and may indicate active or historic leakage. Further evaluation by a Florida-licensed mold assessor and remediation by a Florida-licensed mold remediation contractor in accordance with Chapter 468, Part XVI, Florida Statutes, is recommended.

The overall bathroom condition showed items that need attention at the time of inspection. Visible deficiencies were noted in this area, and repair or correction is recommended as needed. Recommend further evaluation and repair by a qualified contractor. Repairs should be completed to address the observed bathroom condition.

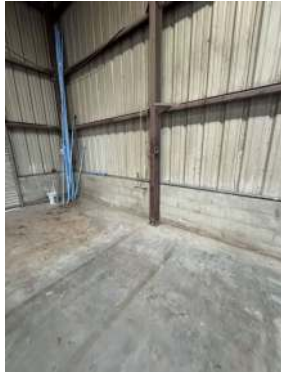
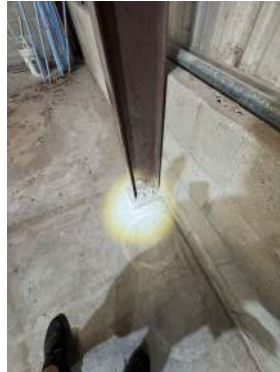
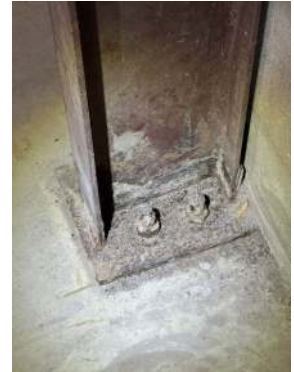
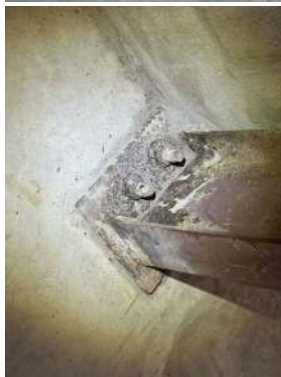
### 6.8.2 Post Deterioration

A steel column within the warehouse interior exhibits deterioration, corrosion, and section loss at its base consistent with prolonged moisture contact at the slab interface. Deterioration at the base of a load-bearing structural member may compromise the column's load-carrying capacity over time, and the structural significance of the condition cannot be determined through visual inspection alone. Evaluation by a Florida-licensed structural engineer is recommended, along with correction of any moisture migration to the column base.

A steel column within the warehouse interior exhibits corrosion and section loss at its base. Evaluation by a Florida-licensed structural engineer is recommended to determine the structural significance of the condition and to specify appropriate repair or reinforcement. Interior CMU walls exhibit through-wall openings that compromise the wall's integrity and pest, dust, and moisture isolation; repair by a qualified masonry contractor is recommended. Source moisture migration to affected components should be identified and corrected.

Deterioration was observed at a post. Recommend evaluation and repair by a qualified contractor. Repair is recommended to address the observed condition and restore the post as needed. Further correction should be made as appropriate based on the contractor's findings.

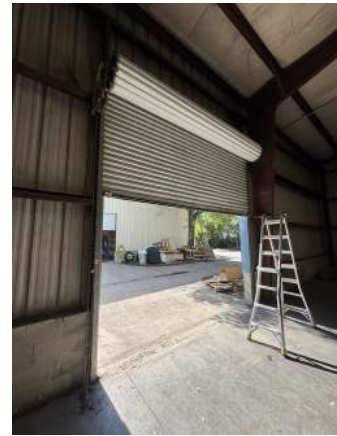
The garage door was observed to stick during operation. Recommend evaluation and repair by a qualified garage door contractor. Repair is recommended to restore smooth operation. Further adjustment or servicing may be needed.

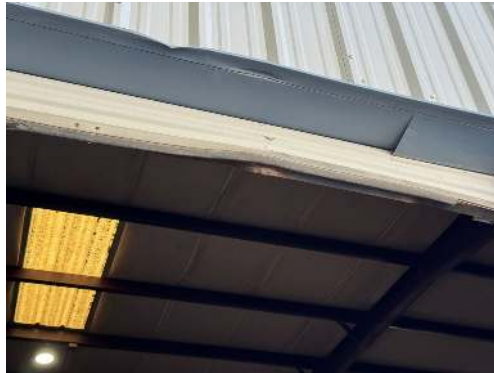
#### 6.8.5 Garage Door Damaged

Damage was observed at the garage door. Recommend repair or replacement by a qualified garage door contractor. Further evaluation of the door and related hardware is recommended to determine the full extent of needed repairs. Repair is recommended.

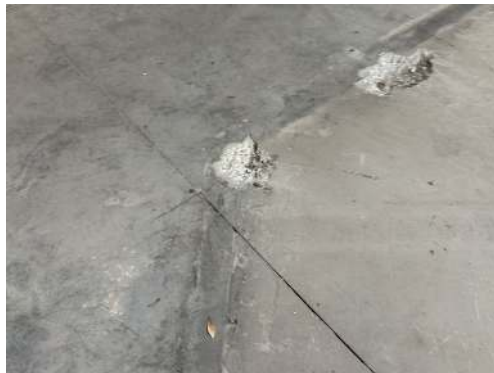
Damage was observed at the slab. Repair is recommended.

Recommend evaluation and repair by a qualified contractor as needed. Further monitoring may be needed after corrections are made.

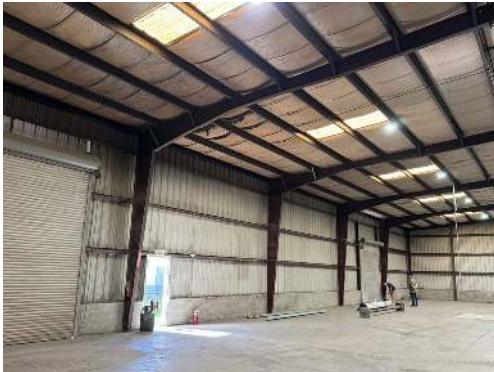
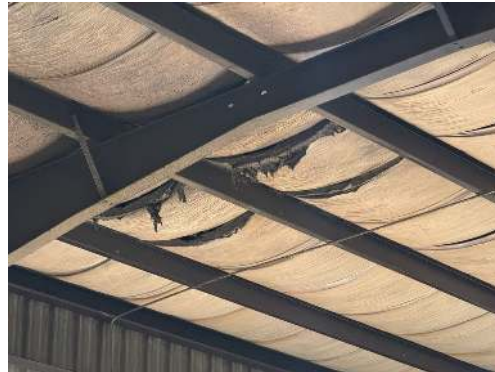
#### 6.9.5 Insulation Deteriorating

Insulation was observed to be deteriorating in some areas. The material appears to be in poor condition and may no longer perform as intended. Recommend evaluation and repair or replacement of the affected insulation by a qualified contractor. Further review of the insulation conditions is recommended as part of the corrective work.
